Case Report

Cochlear Implant Magnet Dislocation Caused by 1.5T MRI: Case Series Study

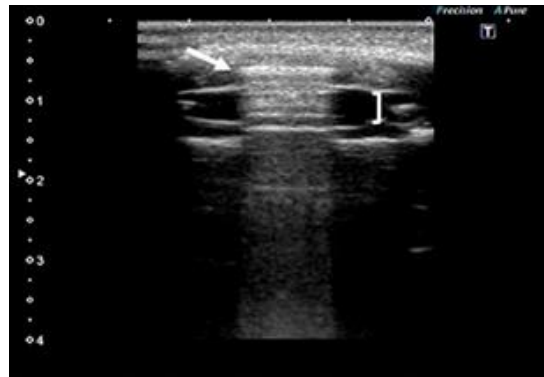
A 76-year-old man with profound bilateral sensorineural hearing loss underwent right cochlear implantation in 2017, and CI522 (produced by Cochlear Ltd. based in Australia) was successfully implanted. One and a half years after the surgery, he underwent endoscopic laminectomy for cervical spondylotic myelopathy. Four days postoperatively, a cervical 1.5T MRI was performed to follow-up on the surgery. The MRI examination was performed with the patient wearing a head bandage. Cochlear Ltd. provided the instruction that a splint should be placed over the magnet, with an elasticized compression bandage wrapped around the head at least twice. Although we did not use the splint, the elasticized compression bandage was wrapped more than twice to prevent MD of the CI. Immediately after MRI examination, however, he complained of pain and swelling in the right temporal region where the CI was implanted. Additionally, the speech processor coil could not connect to the implant. Head radiography revealed partial dislocation of the CI magnet. Initially, manual repositioning without skin incision was attempted to return the magnet to its proper place. After manual fixation, the pain and swelling reduced. The magnet appeared to be at the proper position in a second head radiograph, and the patient could wear the implant. However, remaining dislocation of the magnet was suspected with UE (Figure 1).

Figure 1: The magnet (arrowhead) was not within, but on the silicon bed (bracket).

High resolution computed tomography (CT) with 3D reconstruction confirmed that the magnet was still dislocated. Five days after the MRI examination, we surgically repositioned the magnet with a half circumferential skin incision around the receiver (Figure 2).

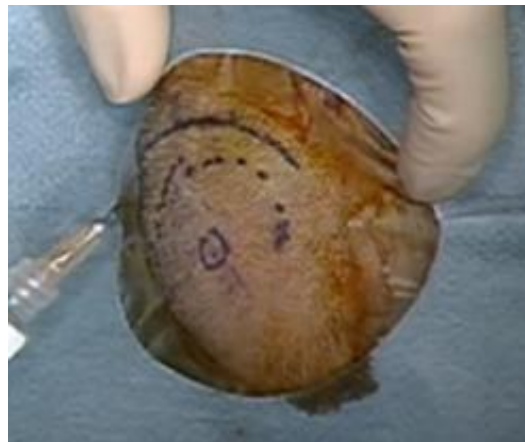
Figure 2: The surgical procedure was planned around the upper half of the silicon bed in case 1.

No cracks in the silicon bed were detected, and some effort was needed to reposition the magnet due to the tight silicon spacing. Postoperatively, the pain and swelling disappeared and the patient started using the CI 20 days after surgery.

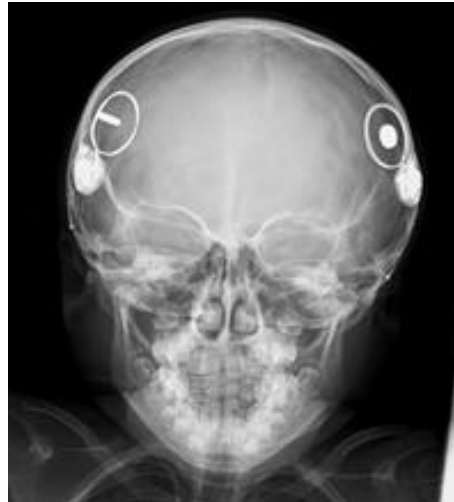
woke up and the examination was terminated. The day after the MRI, the patient's family noticed swelling around the right CI. Radiography was performed and partial MD was detected (Figure 3).

Figure 3: The right magnet was rotated 90°.

Manual repositioning was suggested as an initial treatment option, but surgical replacement of the magnet was performed, as requested by the patient's family, to check for damage to the implant. A post-auricular incision along the existing skin incision (Figure 4) was chosen while preparing for CI replacement. During the surgical procedure, the magnet was easily returned to the correct location.

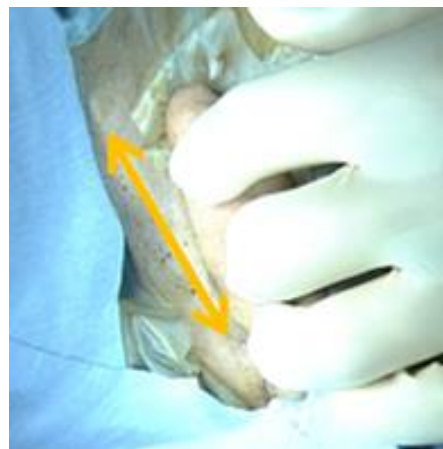
Figure 4: A post-auricular incision along the existing skin incision was selected.

However, careful inspection revealed a crack of the silicon. As MRI needs to be performed frequently in the future for follow-up on the Fanconi anemia, we decided to replace the implant with a new device. After removing the original implant, we discovered that the silicon bed behind the magnet was completely cracked.
